NEARSHORE CURRENTS AND CORAL REEF  
ECOLOGY OF THE WEST COAST OF GUAM,  
MARIANA ISLANDS

4. DESCRIPTIVE NOTES (Type of report and inclusive dates) Technical Report. 4 Feb. - 3 Mar. 1971 and 19 Aug. - 15 Sept. 1971			
5. AUTHOR(S) (First name, middle initial, last name) Howard D. Huddell, J. Craig Willett, and Gregory Marchand

SPECIAL PUBLICATION

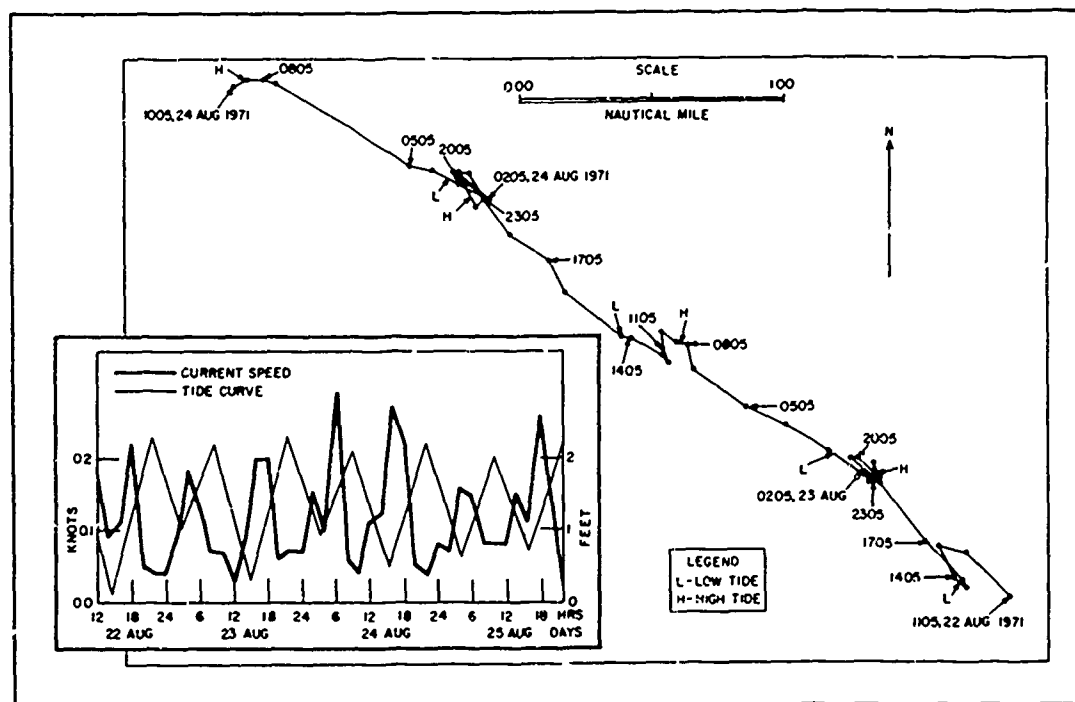
Figure 49. Progressive vector diagram of current from meter #429, 1105, 22 August to 1005, 24 August 1971, and current speeds versus tides from 1200, 22 August to 2000, 25 August 1971.

A similar situation existed during the summer field survey as shown in the data from meter #429 (figs. 36 and 49). Peak speeds occurred during rising tide and lower speeds were recorded during ebb. Speeds were generally higher during the summer, reaching a maximum of 0.55 knot (.275 m/sec). Currents flowed northwest during flood and were variably southeast and northwest during ebb.

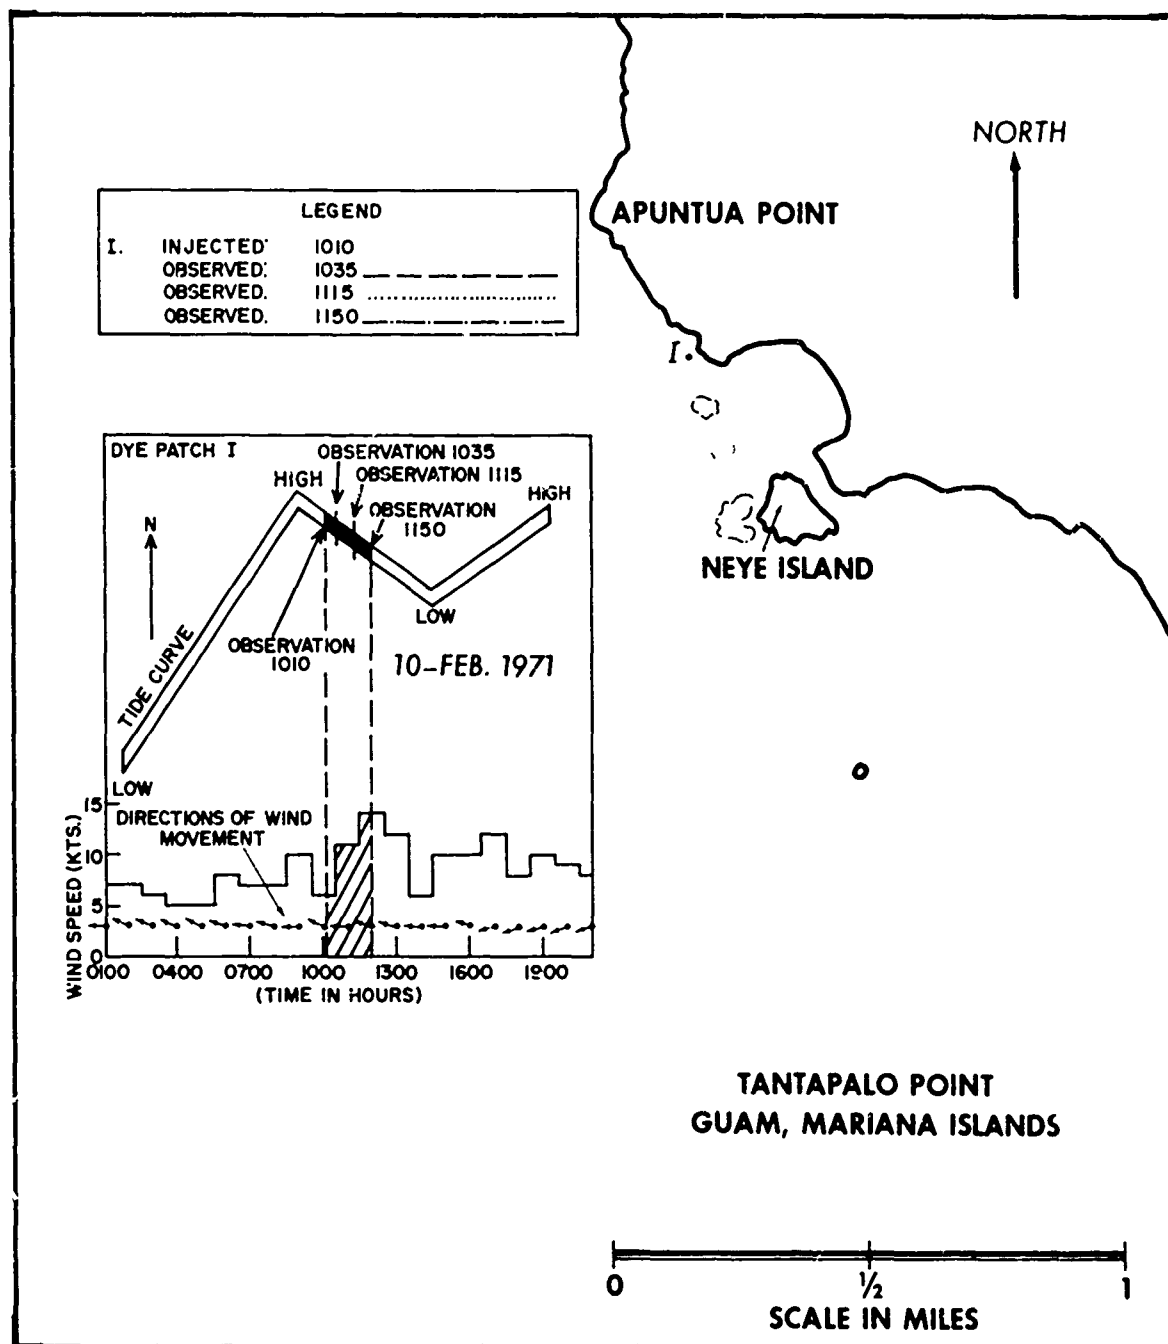
Figure 50. Dye movement at Tantapalo Point on 10 February 1971, A.M.

Two dye patches were tracked off Tantapalo Point on 10 February (figs. 50 and 51) and an aerial photograph was taken of the sewage effluent on 26 February (fig. 52). Dye and sewage movements confirmed the general pattern shown by the current meter data. Four dye injections were made off Dadi Beach during August and September (figs. 42 through 45). Three of these were observed during the falling tide and showed sluggish eddying currents. One dye patch, observed during flood, was subject to a relatively strong current setting to the south (fig. 42). This southerly flow during flood was exactly opposite to the general pattern at Tantapalo Point and illustrates the eddying nature of the currents in Agat Bay.

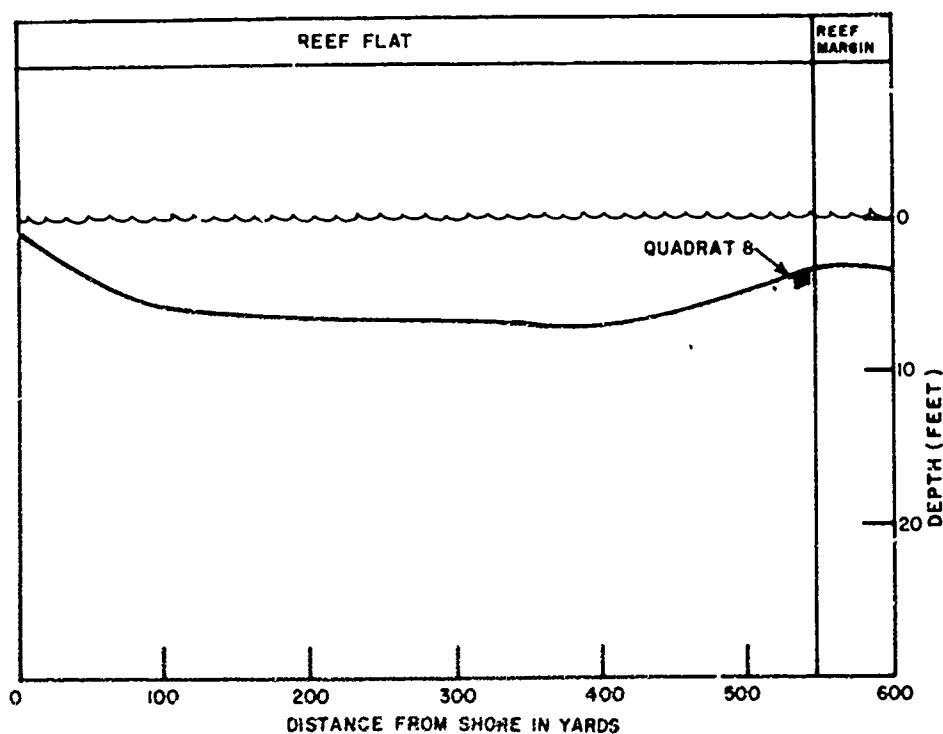
Figure 134. Area chart and reef profile for Tumon Bay ecological study.

Three days of observations were made of the fringing reef at Tumon. The reef front had been decimated by the starfish, Acanthaster (crown-of-thorns), and presented an ugly view of dead coral buttresses and pillars. This reef sector now appears to be in an early stage of redevelopment with sponges, algae, the coral Galaxea, and the hydroid Millepora being predominant. The reef flat extends 550 yards (503 meters) from the shore to the algal ridge and encompasses the following zones: (1) beach sand and marine grass (0-100 yards (0-91.4 meters)); (2) sand, and coral of the genera Goniastrea, Porites, and Acropora (100-350 yards (91.4-320 meters)); and (3) sand, rock, and coral of the genera Pocillopora, Acropora, and Porites (350-550 yards (320-503 meters)). A similar traverse was run by Tracey et al. (op. cit.) before the starfish infestation, and comparison of data indicates the reef flat did not suffer
